Update "With-Site-Visit" Reserve Study

Shadow Run at Canyon Lakes Common Areas Kennewick, WA

Report #: 33951-0
For Period Beginning: January 1, 2019
Expires: December 31, 2019

Date Prepared: April 4, 2018

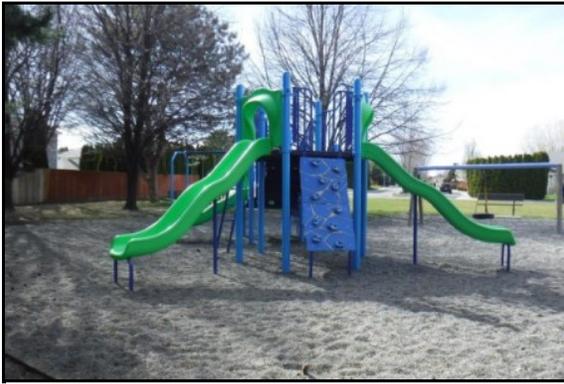
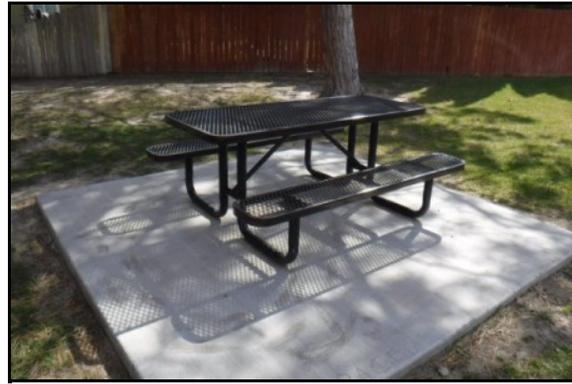
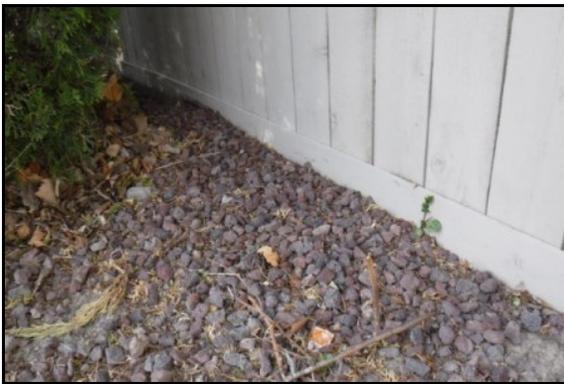
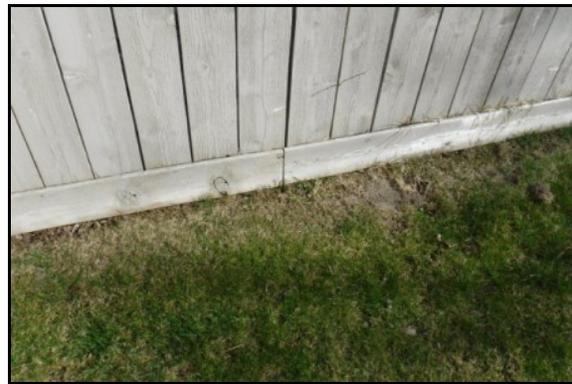
At the time of our site visit we learned that the playground at the main park along S Conway Dr was replaced in 2014, and that picnic tables and pet stations were added in several common areas in 2017. We noted soil against the bottom rail of the perimeter fencing in multiple areas and recommend that the landscaping be regraded to prevent soil from touching wood.

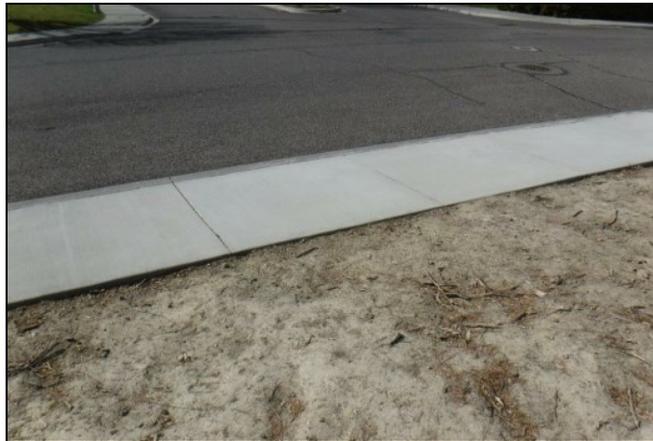
Comp #: 100 Concrete - Repair/Replace

Evaluation: Research with the City of Kennewick found that although sidewalks throughout community are considered public, the adjacent owner is responsible for maintenance of sidewalks which includes repair/replacement of trip hazards and tree root uplift. The City confirmed that the association is responsible for the sidewalks adjacent to common areas. Our source reported that trip hazard repairs were recently performed at the main park on S Conway Drive due to tree roof uplift. Concrete appeared generally intact at the time of our site visit, with local areas of broken curbing at playgrounds.

Due to general age and eventual wear, we suggest a rotating funding allowance to supplement the operating budget for periodic larger scale repair/replacements as reflected below.

Time larger repairs to coincide with Asphalt Seal/Repair (Component #121) and curb painting for cost efficiency when possible. As routine maintenance utilizing operating funds, inspect regularly and pressure wash for appearance. Repair promptly as needed to prevent water penetrating into the base, which can cause further damage. Factors affecting the quality of the concrete include; the preparation of the underlying soil and drainage, thickness and strength of concrete used, steel reinforcement (none likely), and amount and weight of vehicle traffic, if any.

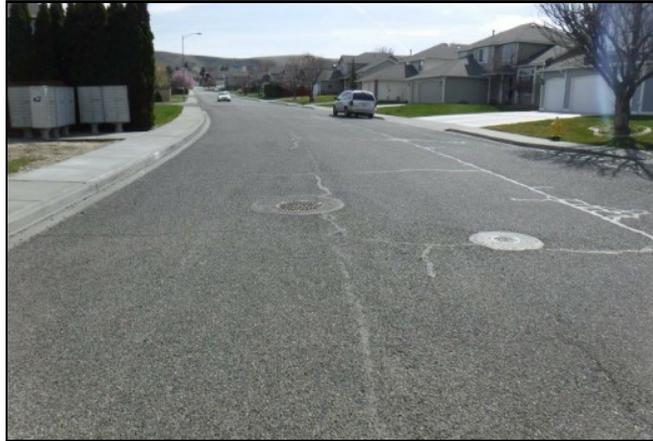
Evaluation: Roads throughout association are reportedly public, therefore they are the responsibility of the local municipality to maintain, repair and replace. No reserve funding required.

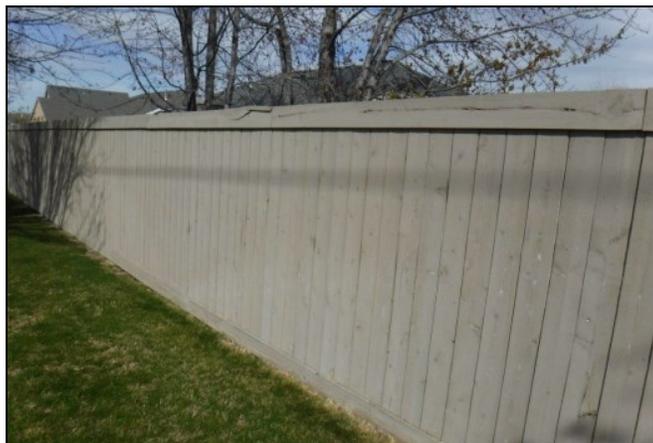
Comp #: 140 Wood Fence - Replace

Evaluation: Six foot tall wood fence appeared generally intact, with a handful of broken/cracked boards noted. Soil was observed against bottom rail of fence in multiple areas; we recommend regrading landscaping to prevent accelerated deterioration of fencing. Fence was stained on one side. Our source reported that fencing was replaced in 2013.

Plan to replace at roughly the time frame below. Typical failures occur from deterioration through end grains, contact with ground and surrounding landscape.

As routine maintenance, inspect regularly for any damage and repair as needed. Avoid unnecessary contact with ground, sprinkler patterns and surrounding vegetation. Regular cycles of stain/paint will help to maintain appearance. Painting or staining the fence has a higher overall life cycle cost but may extend life somewhat in addition to aesthetic benefit.

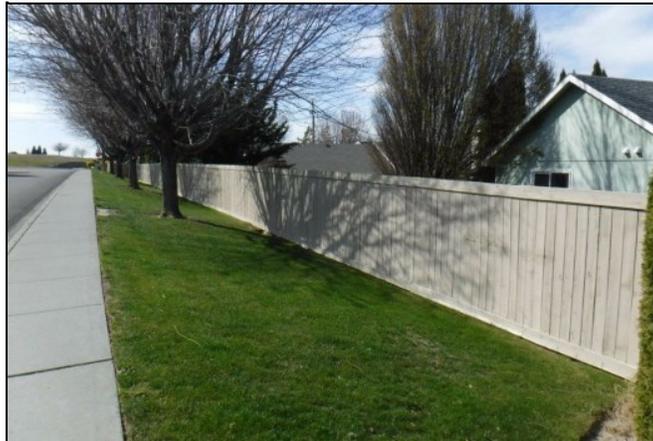
Comp #: 141 Wood Fence - Stain

Evaluation: The finish on the wood fence appeared in generally intact condition, with minor local peeling in areas. Our source reported that fence was last stained around 2013 when fence was replaced. Fence was stained on one side only.

Regular sealer applications are recommended for the appearance, protection, and maximum useful life of the wood. Actual timing of staining will vary based on exposure and quality of material and application. In our experience, quality solid-bodied stain typically produces best result. Remove any unnecessary contact with ground and surrounding landscape and sprinkler patterns. Repair as needed and clean prior to sealer application.

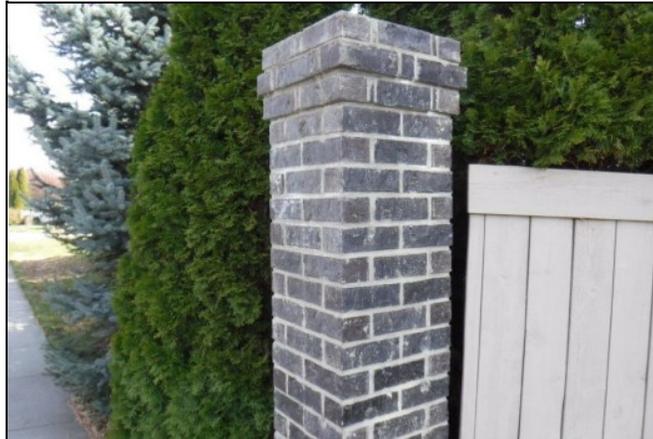
Comp #: 145 Brick Columns - Replace

Evaluation: Brick columns appeared generally intact, with no major damage or deterioration noted of brick or grout. Our source reported that columns were added at the time of the 2013 fence replacement.

There is no basis to expect complete replacement of these study brick structures, therefore no reserve funding included. As routine maintenance, inspect, repair and clean as needed utilizing general maintenance operating funds. Update future reserve studies should need for large scale repair or replacement arise.

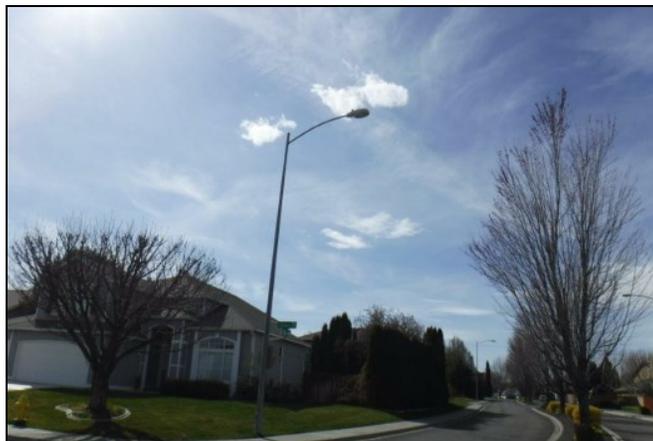
Comp #: 160 Pole Lights - Replace

Evaluation: Commercial quality cobra head street lights are reportedly the responsibility of the local municipality/utility to maintain, repair and replace, therefore no reserve funding included.

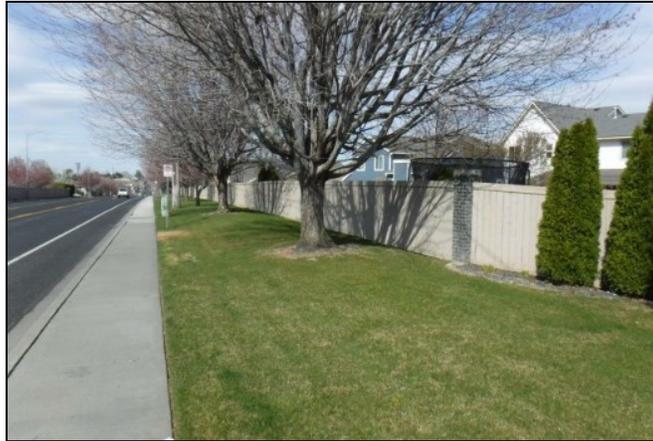
Evaluation: Extensive common area landscaping consisting of primarily mature trees, shrubs and turf. Our source reported that trees were recently removed from the park along S Conway Drive due to tree root damage to adjacent sidewalk.

Currently, landscaping maintenance is funded out of the operating budget however we have included funding for periodic larger projects that cannot be easily absorbed into the operating budget. As associations age, many find the need or desire for larger scale refurbish projects not covered within the maintenance contract, and they allocate funds within reserves. These types of projects can include: bed renovations, major replanting, large scale bark or mulch replacements, turf renovations, drainage improvements, irrigation system extensions / replacement, etc.

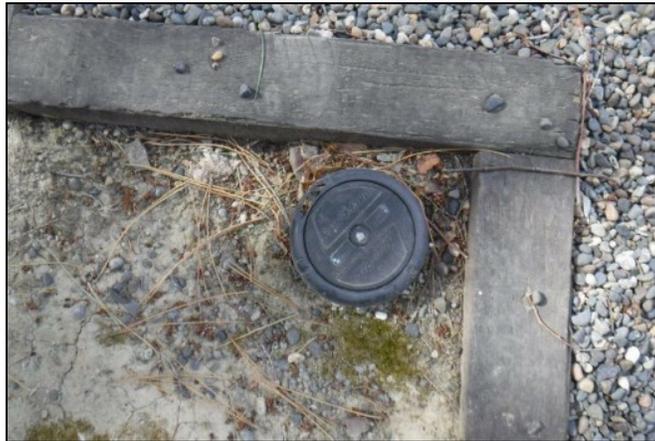
Comp #: 175 Irrigation System - Repair/Replace

Evaluation: Our visual observation of the irrigation system was limited as the majority of system components are below grade. No reports of repairs or problems. At the time of this study, no information (plans and/or specifications) was provided to us regarding the extent of the irrigation system.
