Shadow Run at Canyon Lakes Common Areas *Kennewick, WA*

Report #: 33951-3
Beginning: January 1, 2025
Expires: December 31, 2025

RESERVE STUDY Update "With-Site-Visit"

December 9, 2024

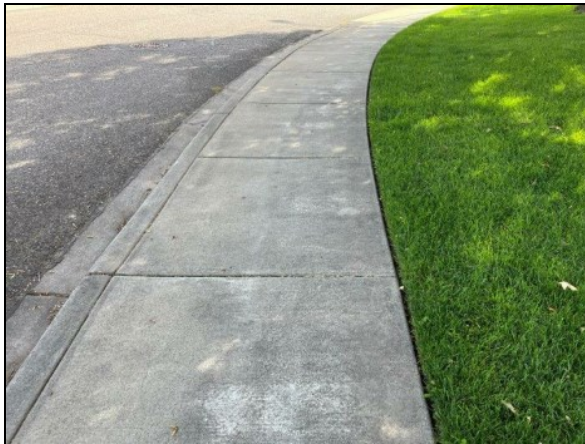
Comp #: 100 Concrete - Repair/Replace**Quantity: Sidewalks, etc.**

Comments: Research with the City of Kennewick found that although sidewalks throughout community are considered public, the adjacent owner is responsible for maintenance of sidewalks which includes repair/replacement of trip hazards and tree root uplift. The City confirmed that the Association is responsible for the sidewalks adjacent to common areas. The Association's sidewalks did not appear to have unusual wear or damage. Some grass was beginning to grow between sidewalk panels, which could eventually cause damage to the concrete.

Due to general age and eventual wear, we suggest a rotating funding allowance to supplement the operating budget for periodic larger scale repair/replacements as reflected below.

Time larger repairs to coincide with Asphalt Seal/Repair (Component #121) and curb painting for cost efficiency when possible. As routine maintenance utilizing operating funds, inspect regularly and pressure wash for appearance. Repair promptly as needed to prevent water penetrating into the base, which can cause further damage. Factors affecting the quality of the concrete include; the preparation of the underlying soil and drainage, thickness and strength of concrete used, steel reinforcement (none likely), and amount and weight of vehicle traffic, if any.

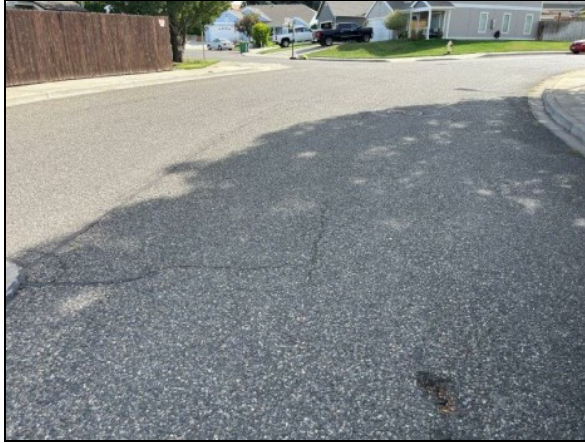
Comments: Roads throughout association are reportedly public, therefore they are the responsibility of the local municipality to maintain, repair and replace. No reserve funding required.

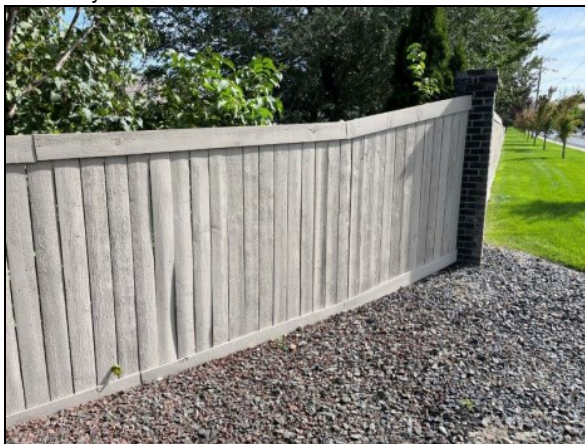
Comp #: 140 Wood Fence - Replace**Quantity: ~ 3,250 LF 6' tall wood**

Comments: The wood fence showed some natural signs of aging, with some warping of the wood. In the areas observed, the fence appeared to be clear of the soil.

Plan to replace at roughly the time frame below. Typical failures occur from deterioration through end grains, contact with ground and surrounding landscape.

As routine maintenance, inspect regularly for any damage and repair as needed. Avoid unnecessary contact with ground, sprinkler patterns and surrounding vegetation. Regular cycles of stain/paint will help to maintain appearance. Painting or staining the fence has a higher overall life cycle cost but may extend life somewhat in addition to aesthetic benefit.

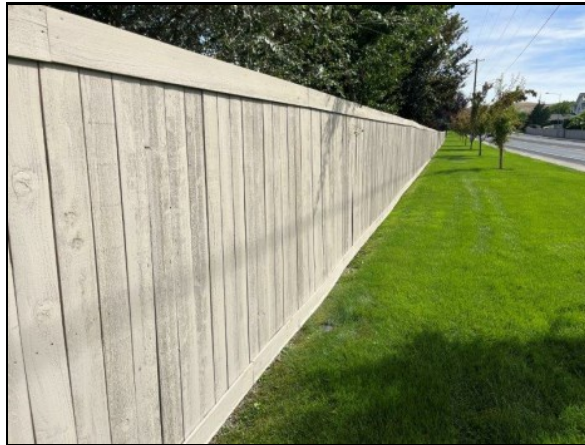
Comp #: 141 Wood Fence - Stain

Comments: The stain on the fences did not appear to be peeling or showing bare wood.

Regular sealer applications are recommended for the appearance, protection, and maximum useful life of the wood. Actual timing of staining will vary based on exposure and quality of material and application. In our experience, quality solid-bodied stain typically produces best result. Remove any unnecessary contact with ground and surrounding landscape and sprinkler patterns. Repair as needed and clean prior to sealer application.

There are three general options for finishing wood fences. The first and least expensive option is to leave it unfinished. The second option is regular cycles of penetrating water repellent (typically clear or semi-transparent). The third option is painting or staining. The second option typically has a shorter useful life and perhaps a lower life-cycle cost than staining/painting. Left unfinished, the wood will "gray" from its exposure to weather and often exhibit mildew - the lesser appearance may adversely affect marketability however. The third option to apply a penetrating stain is similar to painting, in that it will extend the life of the wood fence. The costs for applying the penetrating water repellent can be much less than staining, but needs to be done more often (every two to three years). Using a quality solid-bodied stain is often thought to best balance the objectives of the association and is therefore factored below.

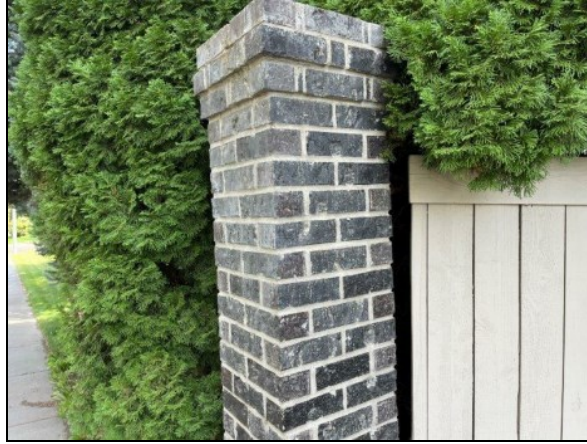
Comp #: 145 Brick Columns - Replace**Quantity: ~ (10) brick**

Comments: Brick columns showed no major damage or deterioration of brick or grout.

There is no basis to expect complete replacement of these study brick structures, therefore no reserve funding included. As routine maintenance, inspect, repair and clean as needed utilizing general maintenance operating funds. Update future reserve studies should need for large scale repair or replacement arise.

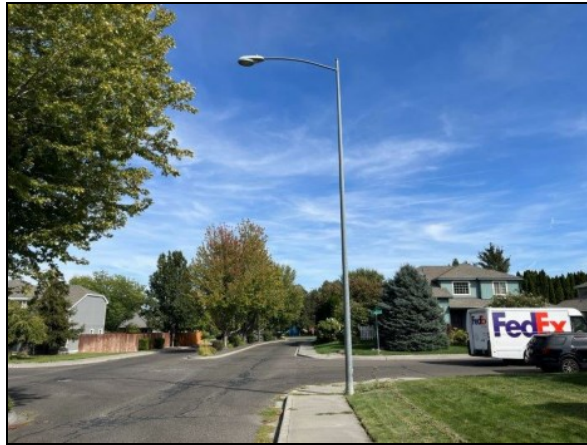
Comp #: 160 Pole Lights - Replace**Quantity: Public street lighting**

Comments: Commercial quality cobra head street lights are reportedly the responsibility of the local municipality/utility to maintain, repair and replace, therefore no reserve funding included.

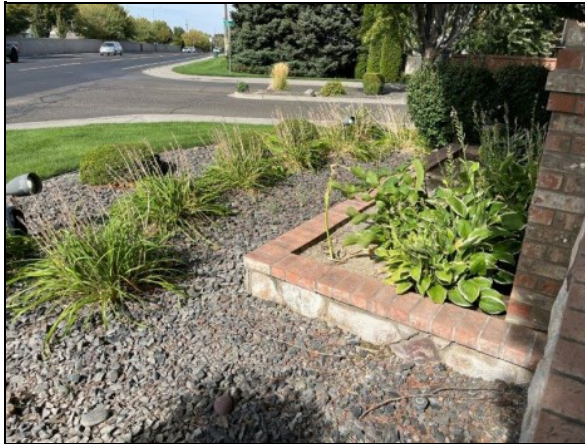
Comments: Common area landscaping consisting of primarily mature trees, shrubs and turf appeared to be maintained regularly. Some trees appeared to be coming to the end of Useful Life. Association reported that heat stress, mower damage, water restrictions, etc, are leading to the need to replace trees. Funding is added in component #171 for ongoing removal and replacement of trees.

Currently, landscaping maintenance is funded out of the operating budget however we have included funding for periodic larger projects that cannot be easily absorbed into the operating budget. As associations age, many find the need or desire for larger scale refurbish projects not covered within the maintenance contract, and they allocate funds within reserves. These types of projects can include: bed renovations, major replanting, large scale bark or mulch replacements, turf renovations, drainage improvements, irrigation system extensions / replacement, etc.

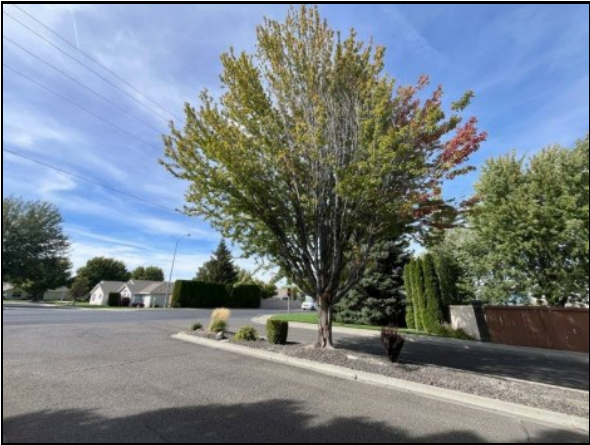
Comp #: 171 Trees - Trim/Remove & Replace

Comments: Some trees appeared to be coming to the end of Useful Life. Association reported that heat stress, mower damage, water restrictions, etc, are leading to the need to replace trees. Funding is added in this component for ongoing removal and replacement of trees. Three cycles of three years is included in this funding, and future funding can be revised as needed.

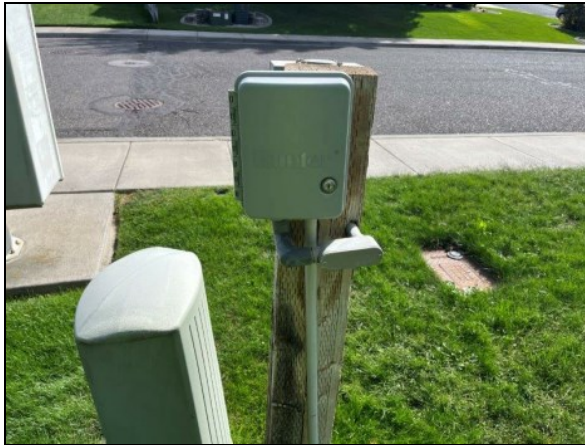
Comp #: 175 Irrigation System - Repair/Replace

Comments: Our visual observation of the irrigation system was limited as the majority of system components are below grade. No reports of repairs or problems. At the time of this study, no information (plans and/or specifications) was provided to us regarding the extent of the irrigation system.

No predictable large-scale costs at this time, however we have included funding for periodic projects that are too large to be comfortably absorbed into the operating budget. Have your landscaper or irrigation specialist periodically unearth sections to check lines for any damage or deterioration. PVC can eventually become brittle and leak (typically not before the 40 year mark of life).
